5.2 North Main Street

#101 North Main Street - East New Market Fire Company

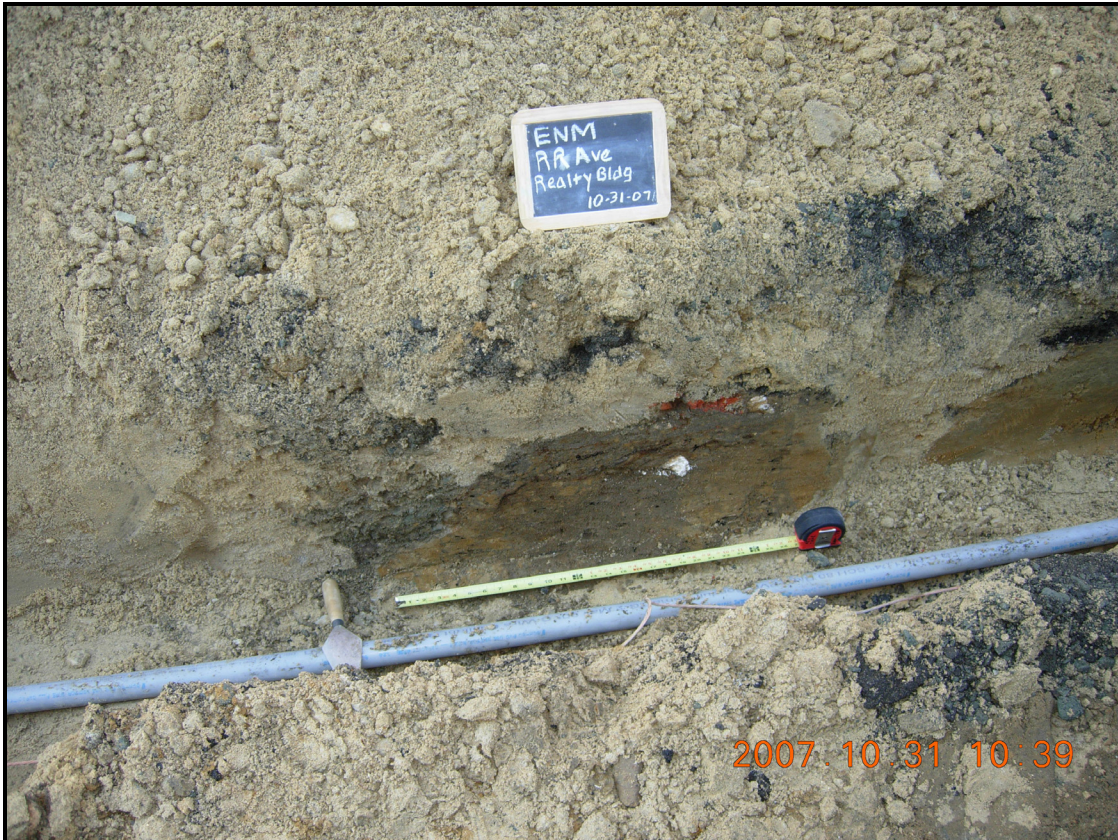
Figure 62. Feature 6 observed in the south wall of a utility trench excavated on the north side of the Realty Building. View looking south. Photo courtesy of the MDSHA ENM field office (October 2007).

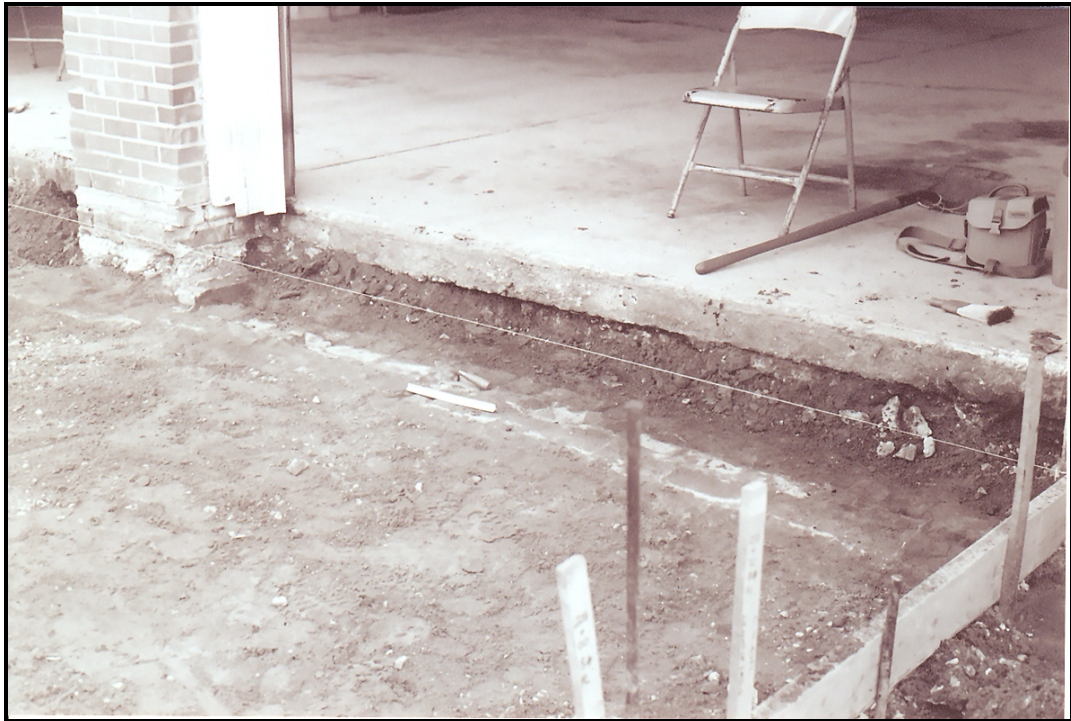
Evidence of the 1913 Millenson's Department Store building footprint was uncovered in the sidewalk along North Main Street (Figure 63). Removal of the concrete sidewalk fronting the south bay of the firehouse exposed a 2-course-wide brick foundation extending from the south bay wall to the center pillar (Figure 64). Designated Feature 7, the pattern of the foundation consisted of a two-brick wide course of runners offset to lie centered over a two-brick wide course of headers. North of the center pillar, the foundation pattern exhibited a two-brick wide course of headers centered over a two-brick wide course of runners (Figure 65). A shallow, 0.2-foot thick cap of very pale brown (10YR 7/4) clayey sand yielded a scattering of ceramics and glass (Table 4).

Figure 64. Brick foundation, Feature 7, exposed below the concrete sidewalk, south bay of the East New Market Fire Company, North Main Street. View looking northeast (August 2007).

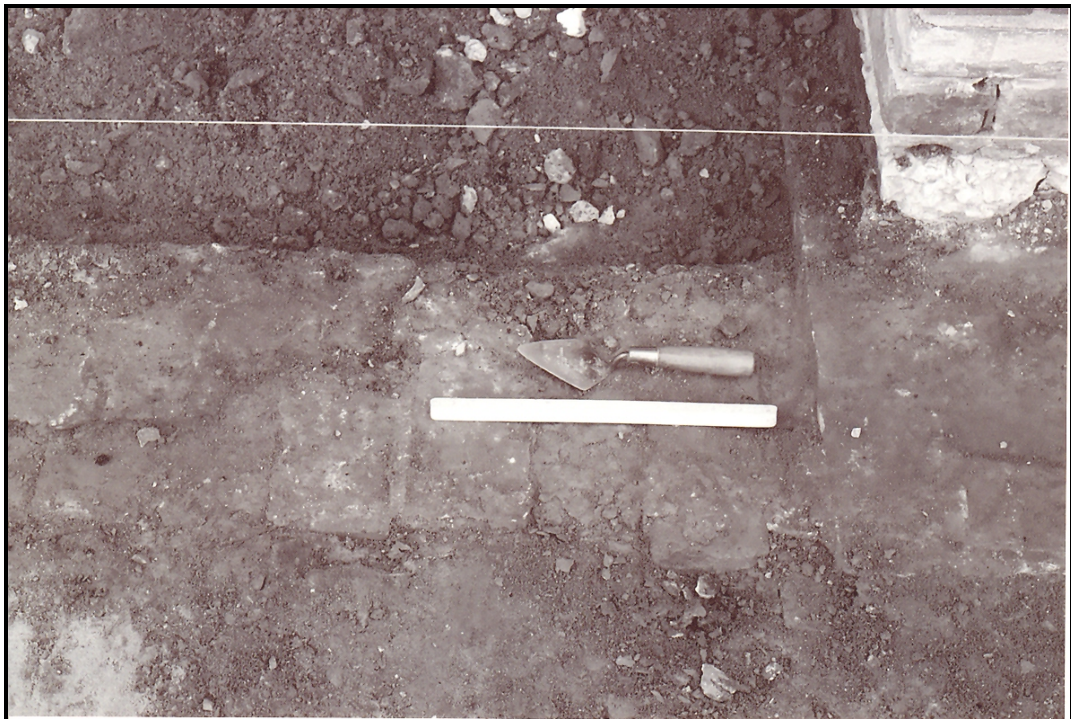
Figure 65. Feature 7, a brick foundation, north of center pillar. Two rows of bricks are constructed long side to long side, with each row short end to short end. View looking east (August 2007).

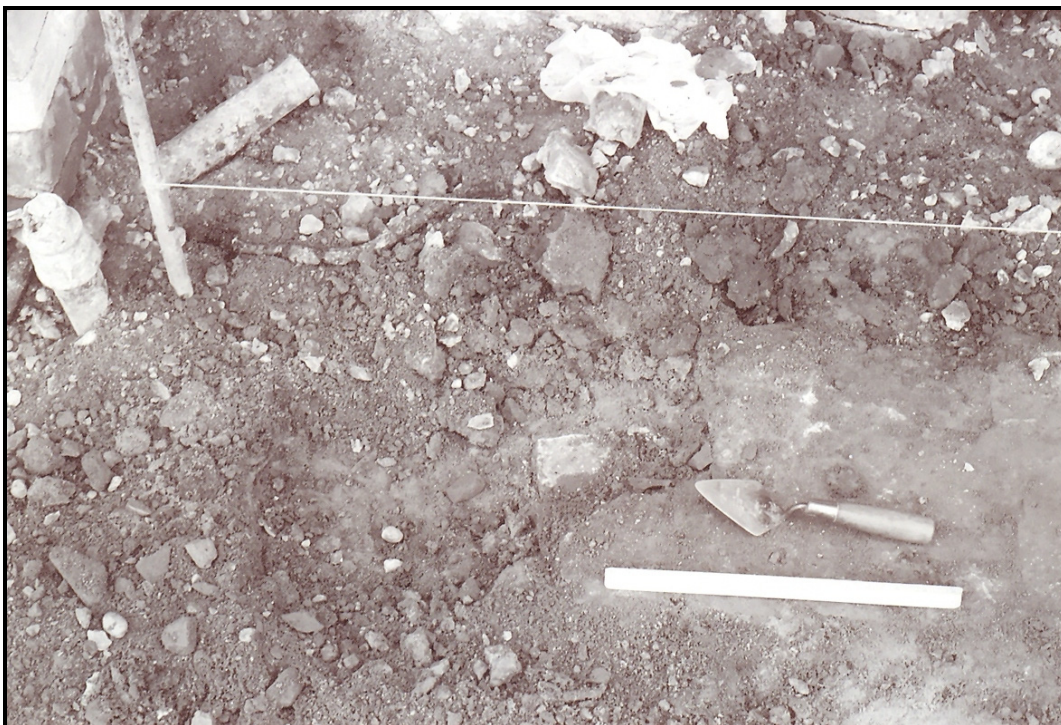
The north end of the foundation had been disturbed due to the installation of an underground storage tank, classified as Feature 8 (Figure 66). Further grading activities exposed a second tank, Feature 9, north of the first tank. A third underground storage tank, Feature 10, was uncovered during the excavation of Inlet Box-1/3 on the Railroad Avenue portion of the property. Parts of the building foundation were exposed during the removal of the third tank, but no evidence of structural remains predating the 1913 building was present. These underground storage tanks are associated with a service station that occupied the building in the late 1930s to early 1940s (East New Market 2005k).

Figure 66. Oil tank, Feature 8, at north end of brick foundation, East New Market Fire Company. Note oil filler neck to middle left of the image. View looking east (August 2007).

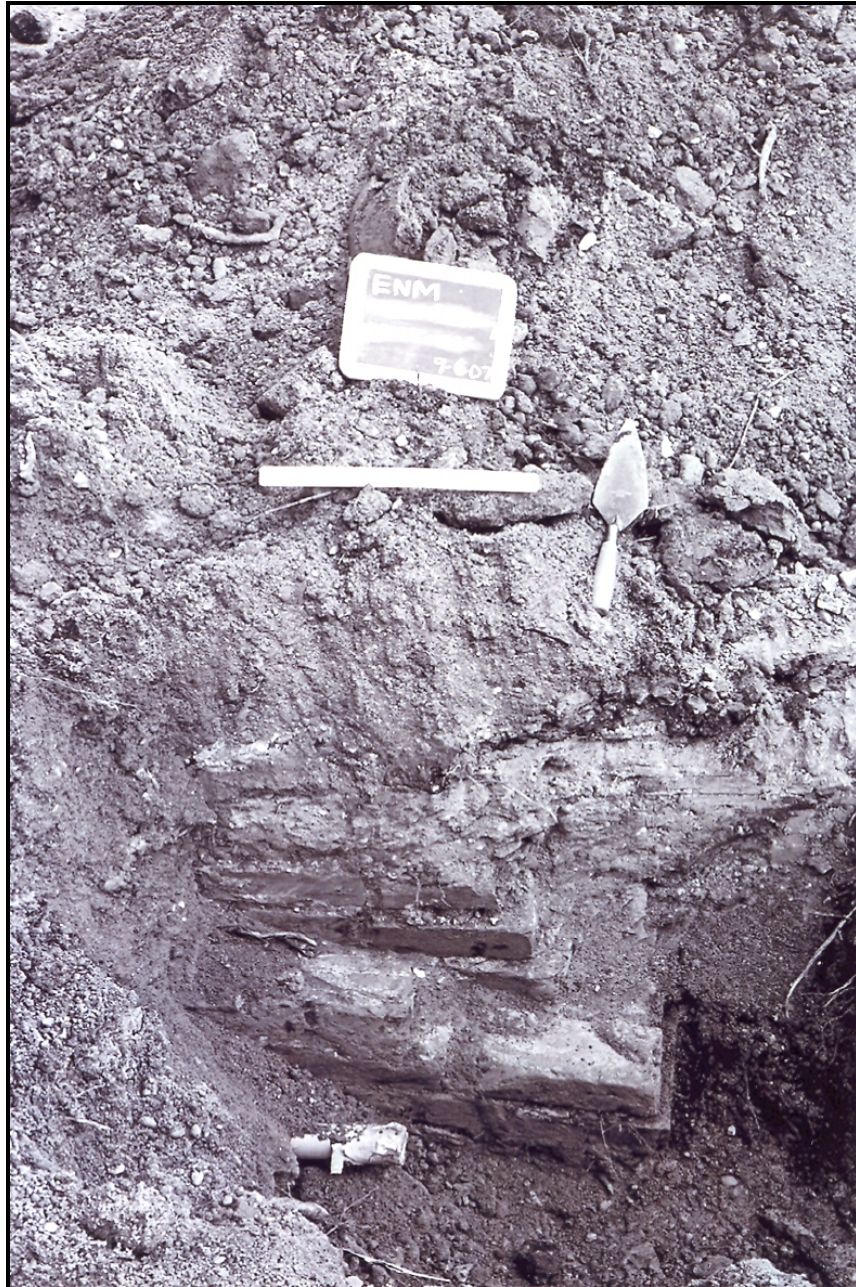
An electric conduit trench was excavated along the north side of Academy Street west from the center of town (Figure 67). The trench excavation exposed the top of a brick foundation approximately 30.0 feet long east to west and six feet north of the roadway (Figure 68). Inspection within the trench uncovered eight courses of brick, approximately 1.5 feet in depth, overlying a yellowish brown (10YR 5/6) silty sand E-horizon. A 0.2 foot-thick layer of gravel and 0.3 foot-thick layer of dark brown (10YR 3/3) silty sand fill containing brick rubble capped the foundation. Designated Feature 11, the corner of the foundation closest to the Main Street and Academy Street intersection exhibited a wider footer in the bottom two to three courses of brick, with the upper courses set back, or to the north. No cultural materials were recovered from the excavated fill. As the trench excavation would not impact the brick, Feature 11 was documented in situ, the conduit installed, and the trench backfilled.

The brick foundation partially exposed in the electric conduit trench is likely part of the foundation of Helsby's Corner Store (1882). A storehouse and blacksmith shop occupied the corner lot of the intersection by 1876, and was subsequently replaced with a new store by 1882 (East New Market 2005l). Helsby's Store was purchased by Trinity Methodist Church in 1936 and became known as Trinity Hall. The building was sold to the Town of East New Market in

Figure 68. Corner of brick foundation, Feature 11, exposed at the southeast corner of the Home Pride Deli parking lot. View looking north (September 2007).

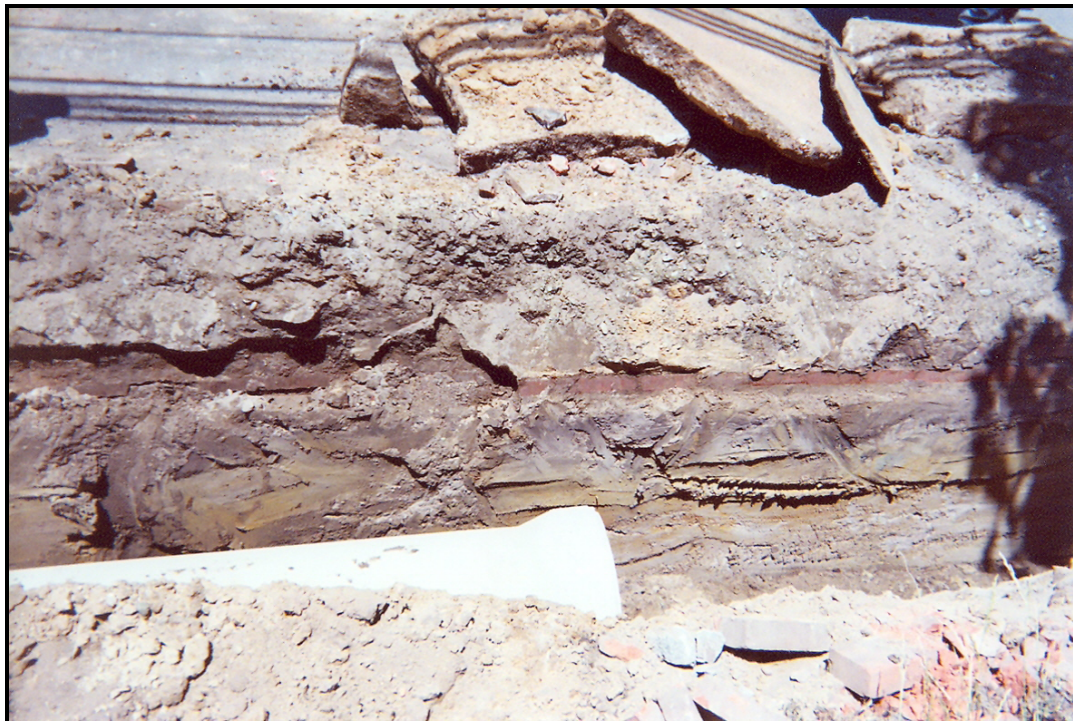
Evidence of early twentieth century development of the town's center was encountered during the streetscape improvements (Figure 67). The excavation of a storm water drain line between Station 111+31.2 and 112+79 revealed a horizontal line of brick two courses deep and wide in the north wall of the trench (Figure 69). The brick feature, labeled Feature 12, extended from Station 112+00 to approximately Station 112+60, where it ended abruptly. A 2.0 foot-thick conglomerate of sandy fill horizons capped the brick feature, while a strong brown (7.5YR 5/6) loamy sand horizon was noted adjacent to and under the brick. Large fragments of a terra cotta sewer pipe were observed contiguous to the brick, as well as in the strong brown loamy sand horizon, particularly towards the eastern end of the trench. At the western end of the trench, directly across from #3 Academy Street, a concrete drain pipe was exposed in the north wall. The end of the concrete pipe aligned just north of, and parallel to, Feature 12. The position of the concrete drain pipe contiguous to the brick feature and the recovery of terra cotta sewer pipe fragments adjacent to the brick suggest that Feature 12 identified in the north trench wall is associated with an earlier drain line feature. Feature 12 was left in place due to its location outside of any direct impacts from the project.

Figure 69. Feature 12, a linear brick feature, recorded in north wall of storm drain pipe trench wall under Academy Street. View looking north (May 2007).

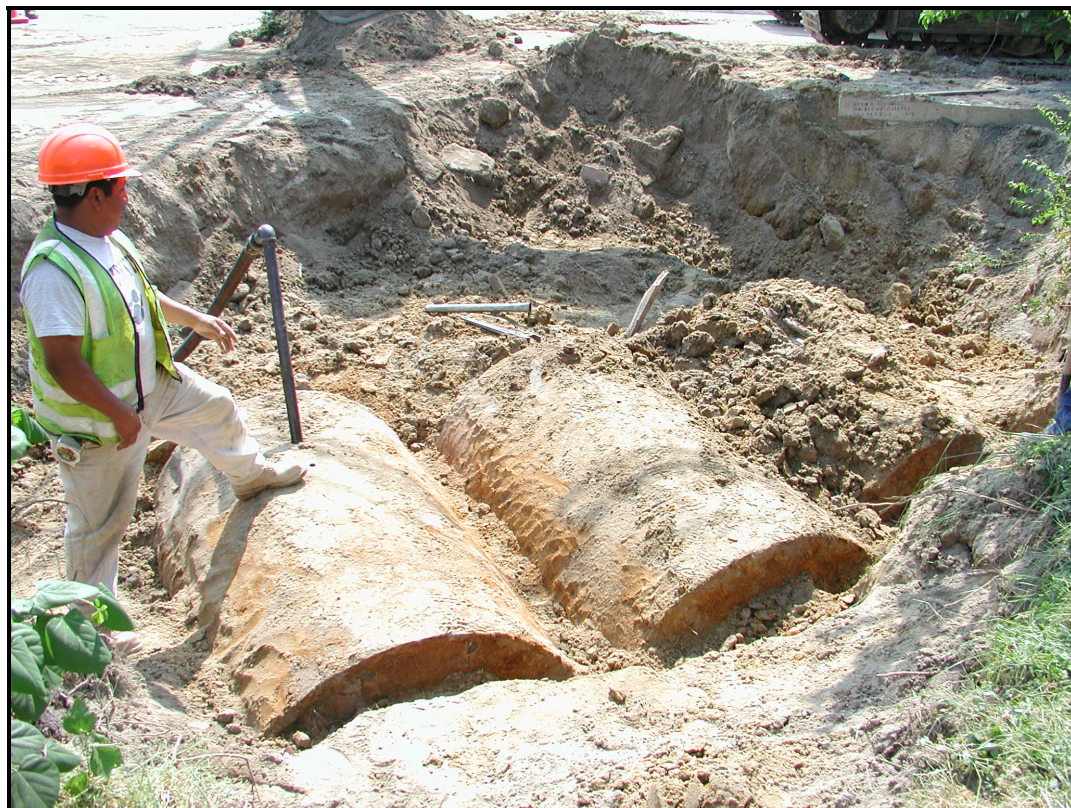
Construction activities at the corner of Academy Street and South Main Street uncovered three underground storage tanks, designated Feature 13 (Figure 70). The top of the tanks was exposed approximately 2.0 to 2.5 feet below ground surface. The northern and middle tanks measured approximately 5.0 foot long by 4.0 foot in diameter. The southern tank, slightly smaller, measured approximately 4.0 foot long by 3.0 foot in diameter. Gleyed soils, consisting of a bluish gray (Gley 2 6/10B) clay and a greenish gray (Gley 2 5/10G) clay, encompassed the bottom third of the tanks, while a series of three, 1.1 to 1.3 foot-thick clayey sand to silty clay fill deposits surrounded the top two-thirds of the tanks (Appendix C). The fill and gley soils were separated by a 1.0-foot-thick black (10YR 2/1) silty sand horizon. The black silty sand horizon and underlying gleyed soils exhibited a strong petroleum odor when exposed to the air.

Figure 70. Underground Storage Tanks (USTs), Feature 13, uncovered in the northeast corner of the Town Park. View looking east (May 2007).
