Drain Line Upgrade and Drainage Outfall Behind Town Hall

East New Market Streetscape Project
Dorchester County

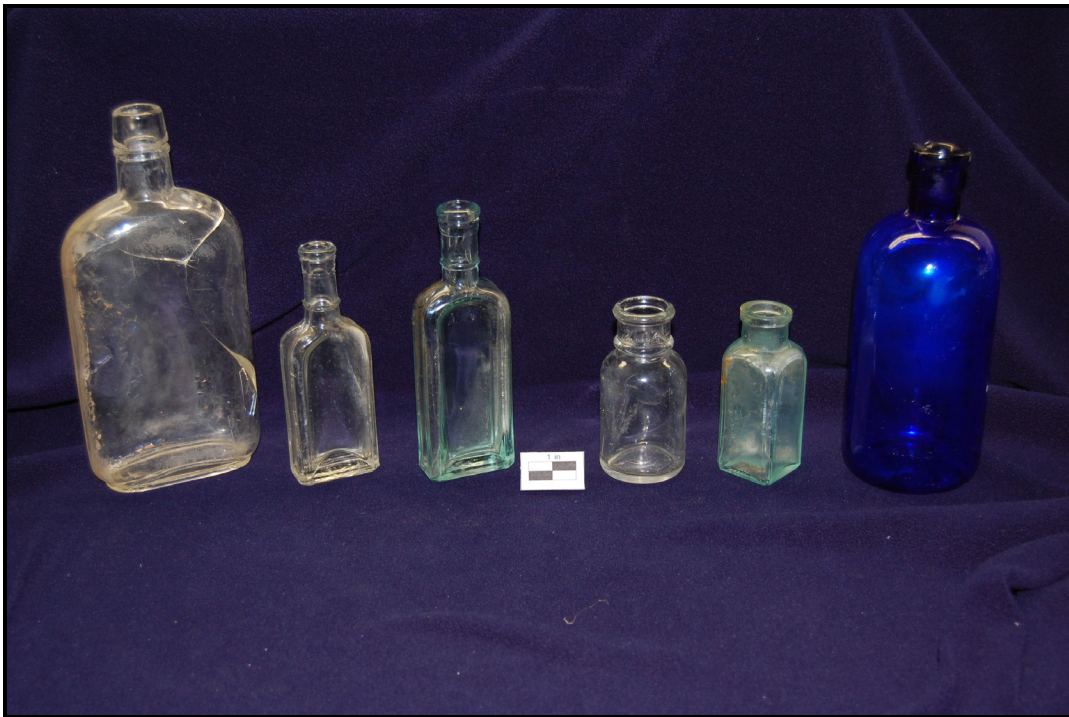
Figure 71. Bottle collection recovered from the fill soils in between USTs.

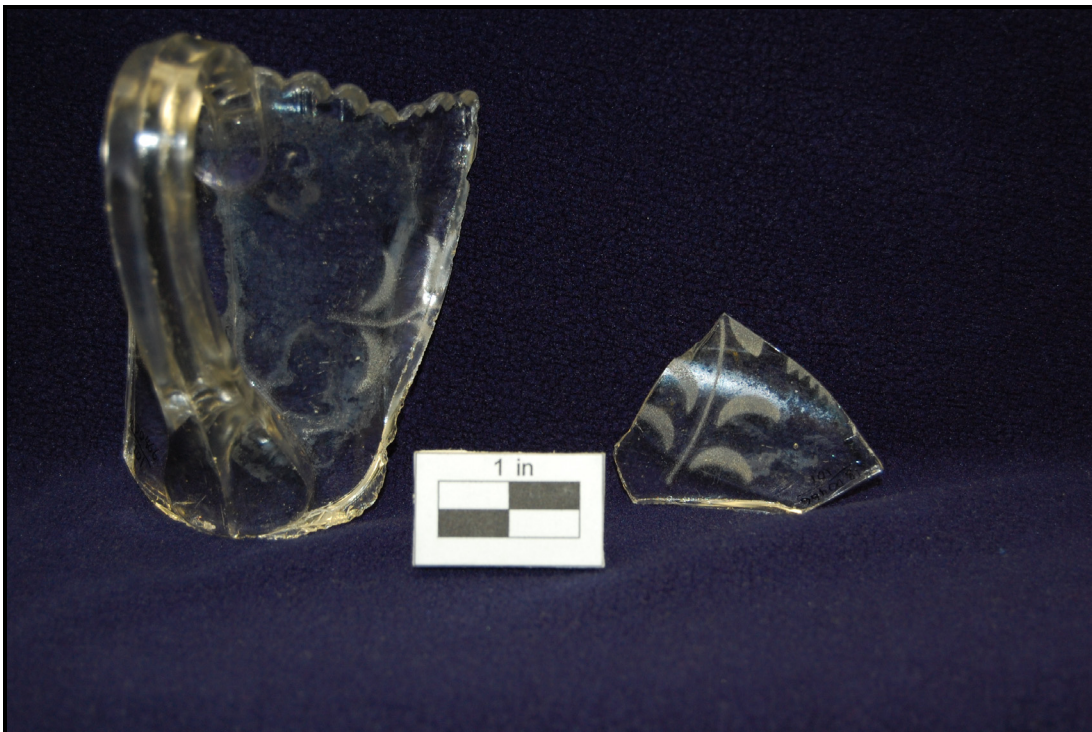
Figure 72. Pressed vessel glass fragments recovered from the fill soils in between USTs.

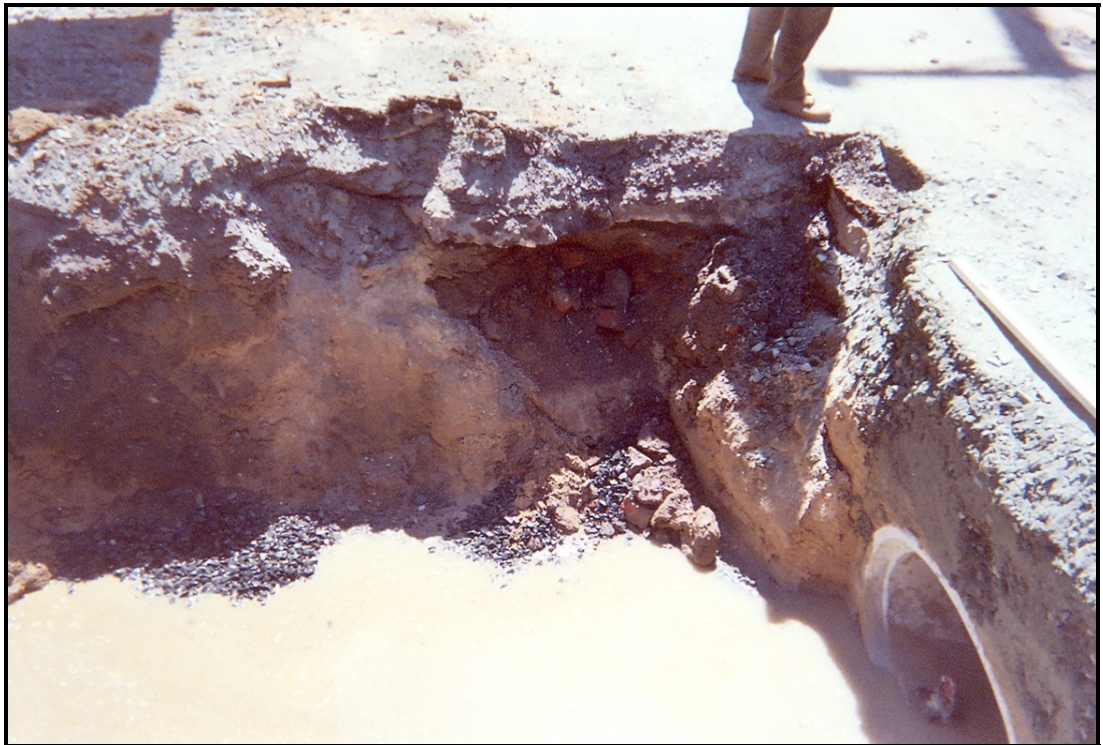
**Figure 74. Feature 14, brick-filled deposit exposed under Academy Street.
View looking east (May 2007).**

The installation of a new drain line under Academy Street at Station 110+85 exposed a small, 3.0-foot-square brick-filled deposit, labeled Feature 14, under the concrete road bed in the middle of the east wall of the trench (Figure 67). A yellowish brown (10YR 5/6) clayey sand E-horizon was noted below and to the sides of the brick deposit (Figure 74). The west wall of the trench did not exhibit the brick feature, indicating that the disturbance did not continue beyond the drain crossing. It is suggested that this brick deposit represents an in-filled utility trench that once contained a drain pipe that connected to the road crossing. Feature 14 aligns with the concrete pipe identified at the western end of Feature 12, the brick linear feature exposed under Academy Street in front of the town park, and likely represents the terminus if the drain line. If the disturbance was associated with gas, sewer or water services, the trench would likely have continued west to the residences on Academy Street.

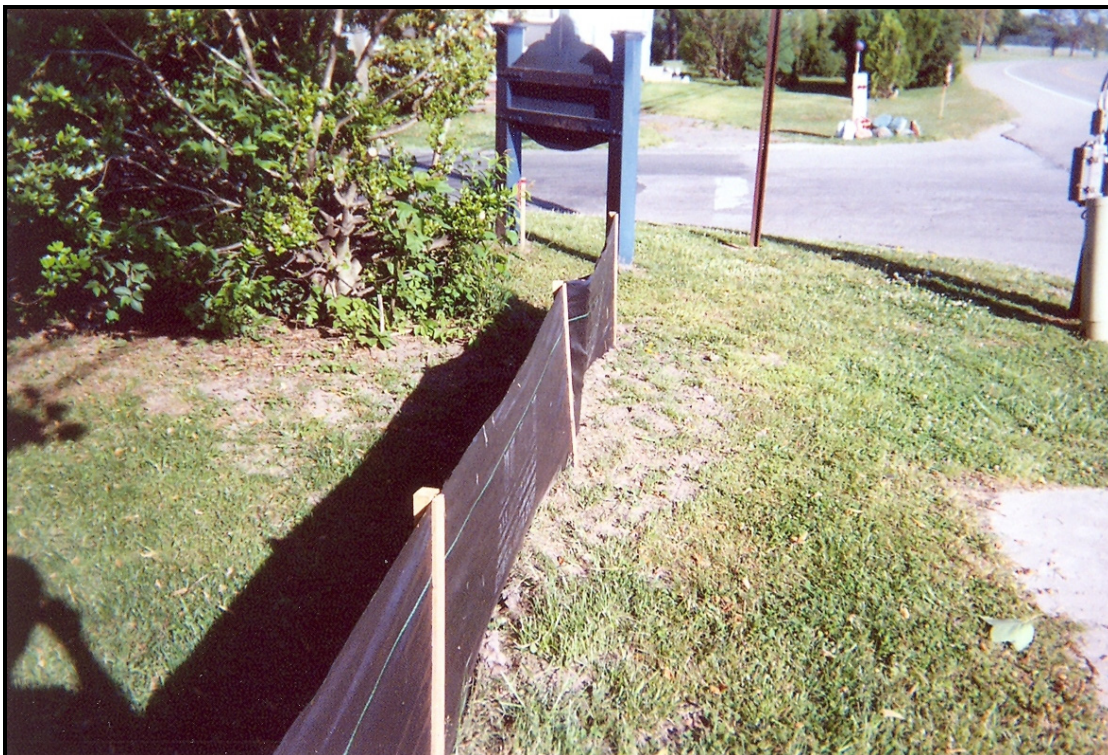
Figure 75. Area of cinder and slag exposed at the base of the silt fence, corner of Academy Street and Creamery Road. View looking west (May 2007).

archeological monitoring of excavations conducted along Academy Street at this property did not yield any evidence of subsurface features or cultural remains associated with the church or the cemetery (Figure 67). In general, a 0.5 foot-thick grayish brown (10YR 5/2) silt loam sod/topsoil horizon was stripped away to expose a brownish yellow (10YR 6/6) silty sand E-horizon. No cultural features were observed in the exposed portion of the subsoil. Approximately 0.6 to 0.8 feet of borrow material was brought in to build up the southern edge of the proposed sidewalk bed. A small, approximately 12.0 foot-long by 0.3 foot-deep area of cinder and slag fill was observed along the silt fence line near Creamery Road (Figure 75). However, the sidewalk bed excavation occurred closer to Academy Street and did not affect the slag concentration.

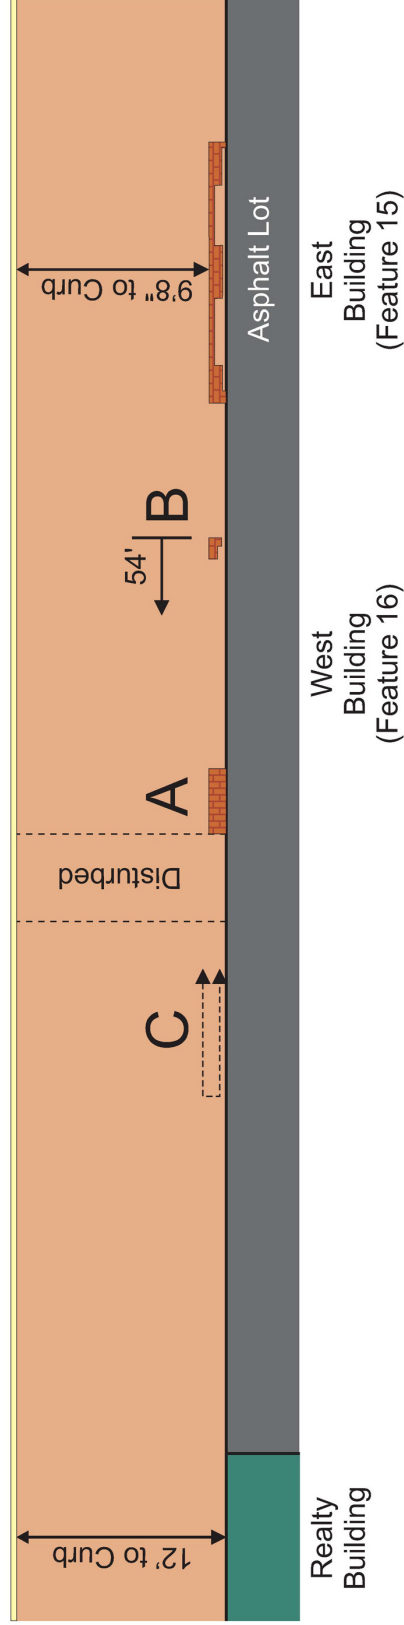
East New Market Streetscape Project Dorchester County		Figure 77	
Legend		Planview of Features 15 and 16, #7 Railroad Avenue	
Section A	Bricks are laid long side to side, one course wide and mortared

July 2008
Section B	Segment fronting roadway same as in Section A, where as the east side is two courses wide		
Section C	First observed in utility trench but was removed during stripping of the bed

Portions of two brick foundations and brick sidewalk were uncovered during the excavation for the sidewalk bed at the Royal Lawns property (Figures 76 and 77). The east building foundation, designated Feature 15, exhibited two courses of brick laid end to end, and three courses of brick in height (Figure 78). The western wall exhibited only one course of brick in width (Figure 79). Due to the limits of excavation, only 4.0 feet of the side walls were exposed during the monitoring task, while the section of wall fronting Railroad Avenue measured 16.3 feet in length. No evidence of a builder's trench was observed in the interior or exterior of the foundation. The interior fill consisted of a 0.5 foot-thick mottled very dark grayish brown, yellowish brown, and yellow (10YR 3/2, 5/6 and 7/6) sandy loam fill overlying a gray and very dark grayish brown (10YR 5/1 and 3/2) silty clay fill. The exterior soil, a brown (10YR 5/3) silt loam, possibly represented an A-horizon.

Documentation of the west building remains, designated as Feature 16, was more problematic. The foundation wall was identified in the profile of the electric conduit trench excavation and backfilled before the archeological monitor could document the resource. Based on the footprint of the backfilled trench, and discussion with the trenching machine operator, the archeological monitor recorded the west end of the foundation 10.0 feet south of the curb and 20.0 feet east of the Realty Building, with the foundation extending for approximately 35.0 feet to the east. During overburden removal of the Royal Lawn property early on 14 November 2007, and prior to the arrival of the archeological monitor, the backhoe operator excavated an extensive portion of the western end of the foundation, removing the foundation and brick sidewalk located to the north (Figure 80). Spotty patches of the remaining foundation were present below the excavated grade to the east. Feature 16 exhibited one course of brick laid long side to long side fronting Railroad Avenue, and two courses wide on the east side wall (Figures 77 and 81). Interior and exterior soils were similar to those identified in the Feature 15.

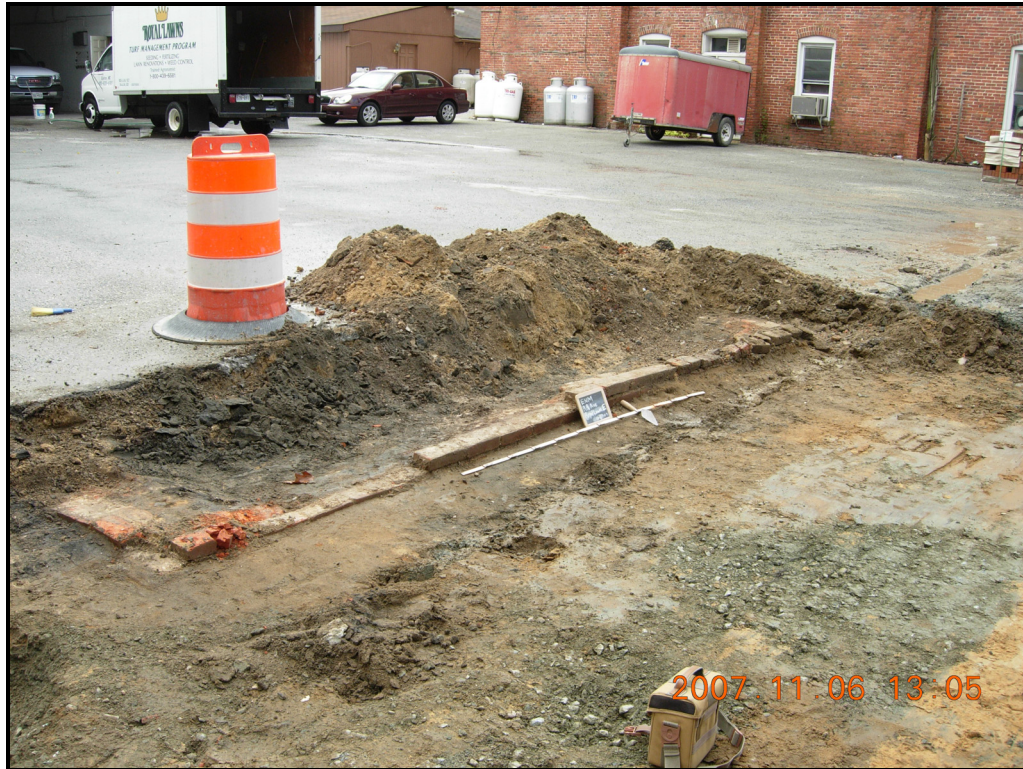
Figure 78. General view of Feature 15, east building foundation. #7 Railroad Avenue, Royal Lawns. View looking southwest. Photo courtesy of the MDSA ENM field office (November 2007).

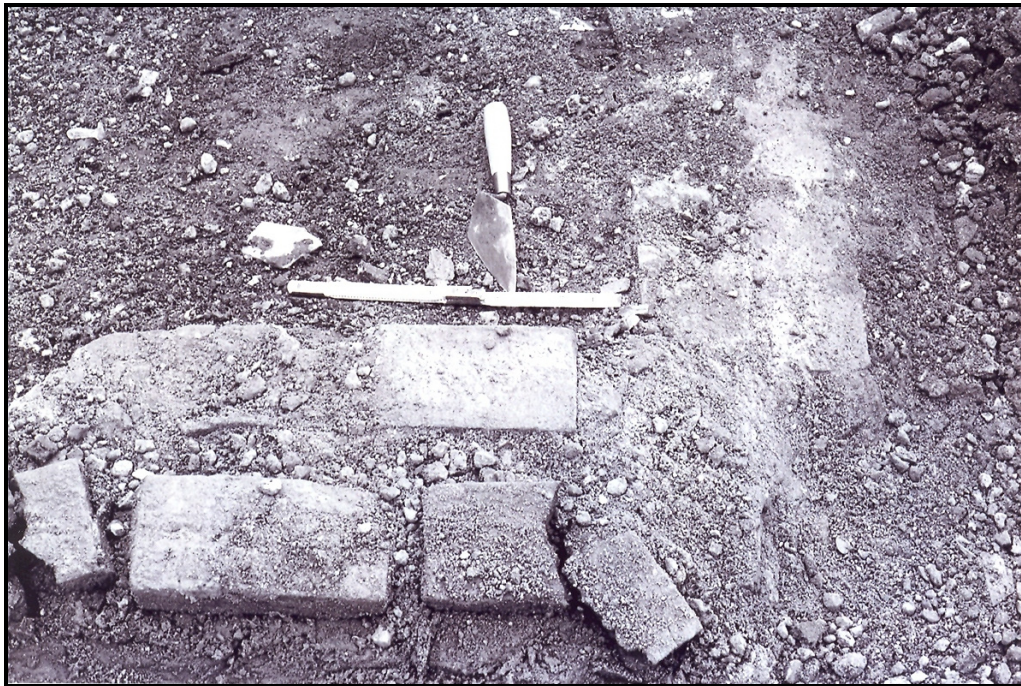
Figure 79. Planview of the northwest corner of Feature 15, east building foundation. #7 Railroad Avenue, Royal Lawns. View looking south (November 2007).
